**US COAST GUARD  
MARINE SAFETY OFFICE PORTLAND, MAINE**

# ***SAFETY ALERT***

## **Encapsulated Rudder Port Fairing Blocks**

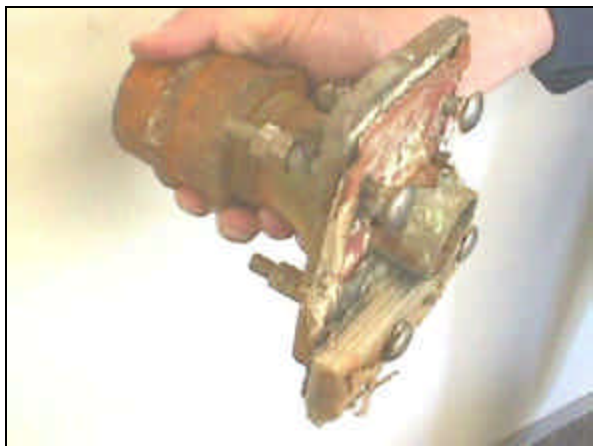
On March 26<sup>th</sup>, 1999 a 35 foot fishing vessel operating in Penobscot Bay experienced a severe flooding incident involving the failure of the vessel's rudder port fitting. Examination of the vessel after salvage found that the vessel's rudder port fitting had been mounted to the hull on a wood fairing block by the manufacturer. This fairing block failed, and when the rudder port fitting tore away from its mount, a significant hole opened in the fiberglass hull.

*Above, the failed rudder port fitting. The fishing vessel involved in the March 26<sup>th</sup> incident nearly sank when the wood fairing block beneath the rudder port fitting failed, tearing the fitting from the hull.*

Operators of vessels fitted with similar rudder port fitting installations are encouraged to carefully inspect them, and their associated steering systems, for potential failure. Proper inspection would include a close visual examination of the fitting while the rudder is cycled through its full range. Any movement of the fitting or water seepage is a sign of potential problems. Major boat manufacturers in Maine indicate that current boat building techniques include installation of the rudder port fitting to the hull on solid reinforced fiberglass, without the use of wood laminates, due to the potential for wood rot, expansion and deterioration when wet.

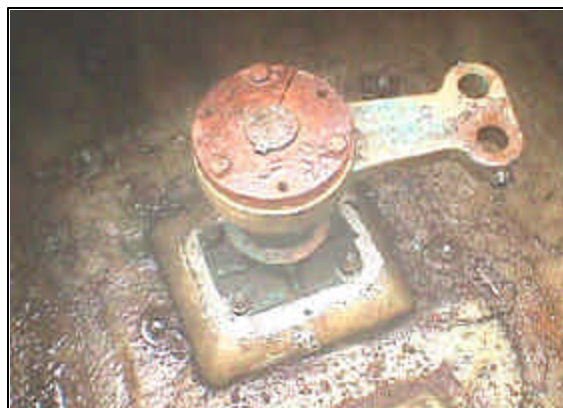
*Encapsulated rudder port fairing blocks can be identified by a fiberglass covered block between the hull and rudder port fitting.*

While the original strength of the mounting of rudder port fittings on these vessels may have been acceptable, Coast Guard safety officials are concerned that the possibility of rot and possible delamination of the wood fairing block from the hull may lead to flooding accidents similar to that experienced in Penobscot Bay on March 26<sup>th</sup>.
